Investigation of the train accident

22 July 2004

Pamukova, Turkey

3 September 2004

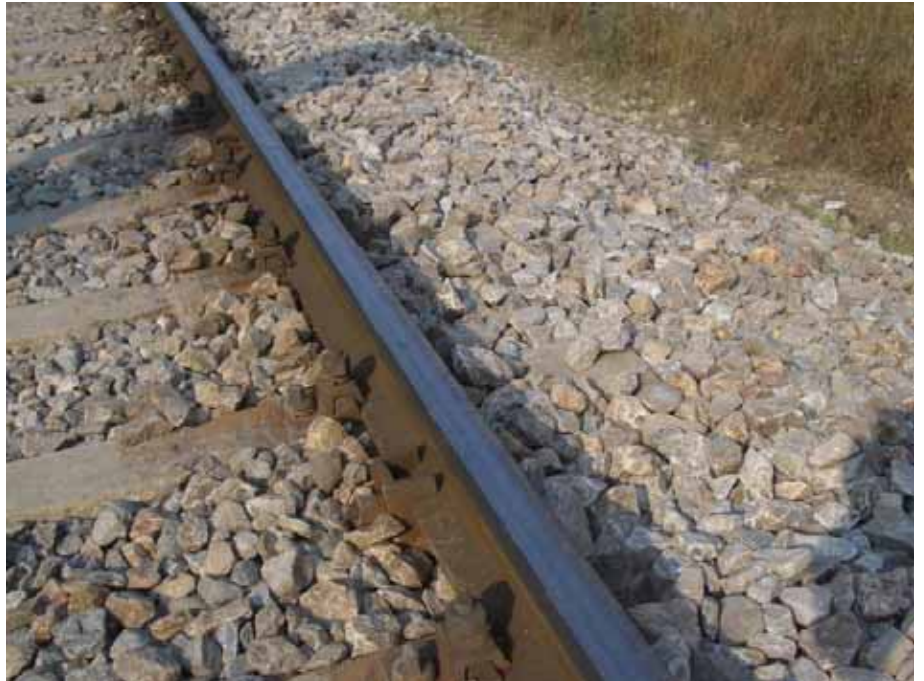
Figure 1 Point of Derailment

At the point of derailment no climbing marks could be found.

As at this point the wheelset of the second coach had a lateral displacement outside the track of 90 cm it is most probable that the wheelset derailed at an earlier point.

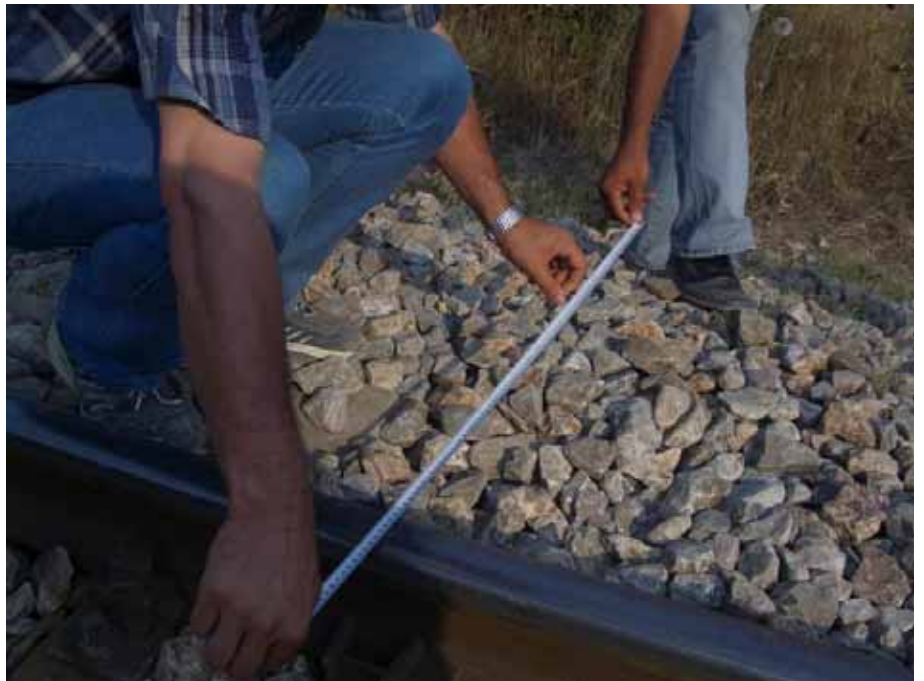
Figure 2 Wheelset was stepped out over 90 cm

In the left hand rail of this picture a rather poor weld can be observed. This weld is at a short distance from the point of derailment in the opposite rail. The influence of a concentrated geometrical defect as caused by this poor weld has been investigated in the simulations with ADAMS/Rail. The transverse rail profile did not show any substantial deviations.

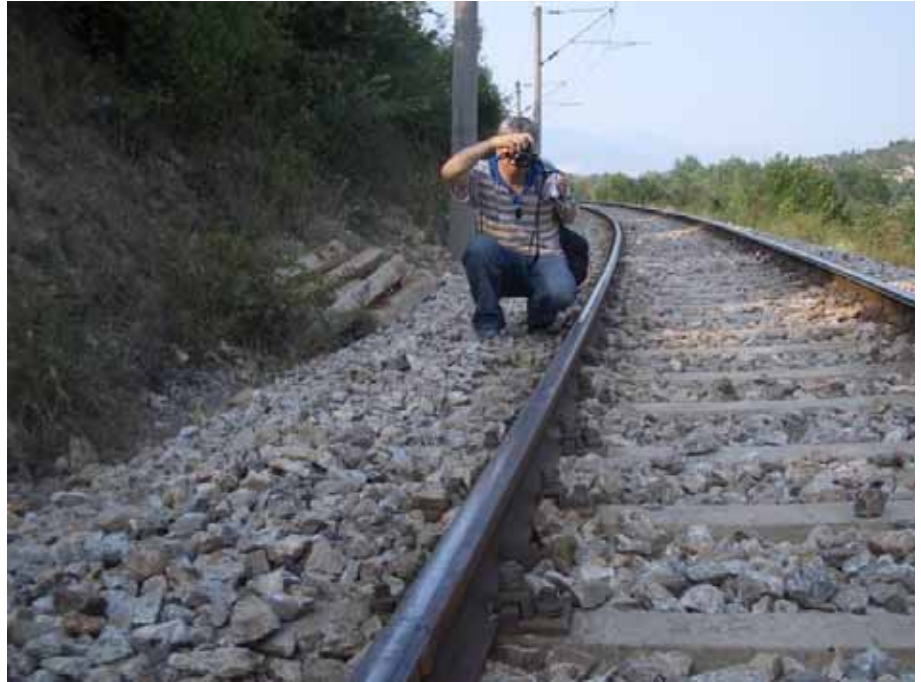
Figure 3 Curve seen from Ankara to Istanbul

Here the track is viewed in the opposite direction with the poor weld now in the right hand rail. The contact band on the rail is at the right place approximately in the middle. There are no lateral shifts and also at the weld the contact band seems to be at the right place.

The fastening system seemed to be in good condition: no loose fasteners between rail and baseplate and between baseplate and sleeper.

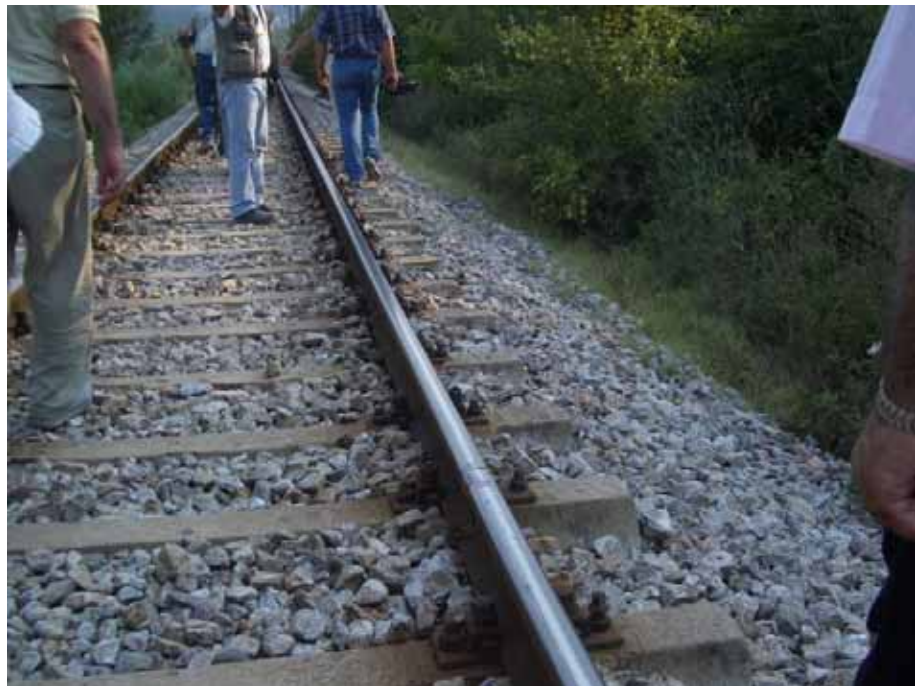
Figure 4 Transition curve seen from Istanbul to Ankara

Walking through the curve with $R = 345$ m. The concrete sleepers are well embedded in the ballast and there is also a enough ballast shoulder to guarantee sufficient lateral track resistance.

During the inspection special attention was given to deviations in the track geometry and in particular to local irregularities. Despite the one poor weld no severe irregularities were found.

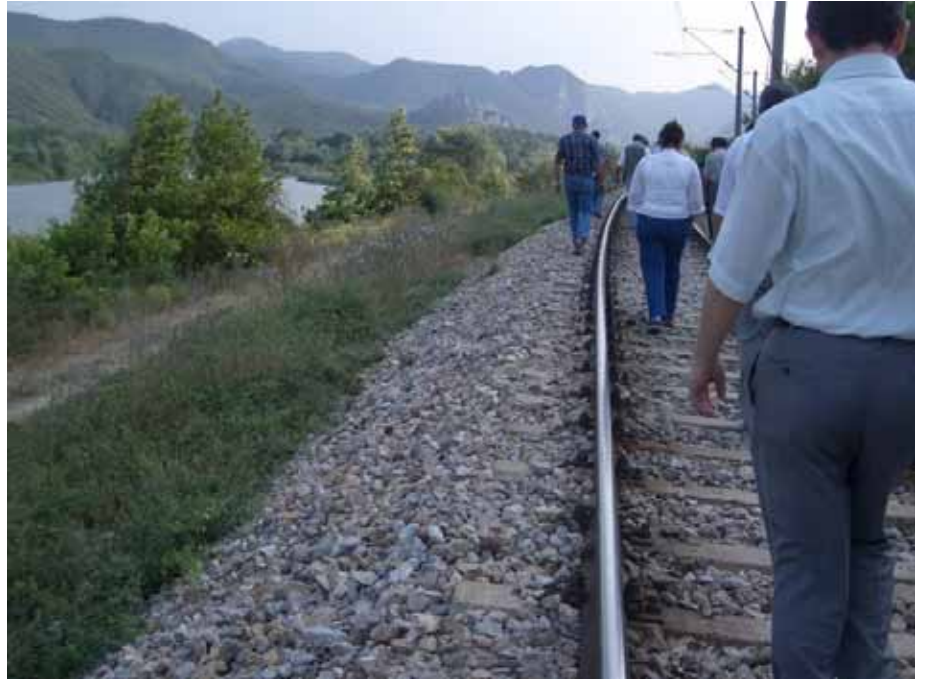
Figure 5 Mid of curve seen from Istanbul to Ankara

At the point of derailment there is plenty of ballast. Also from other observations in the track no lateral shifts could be identified.

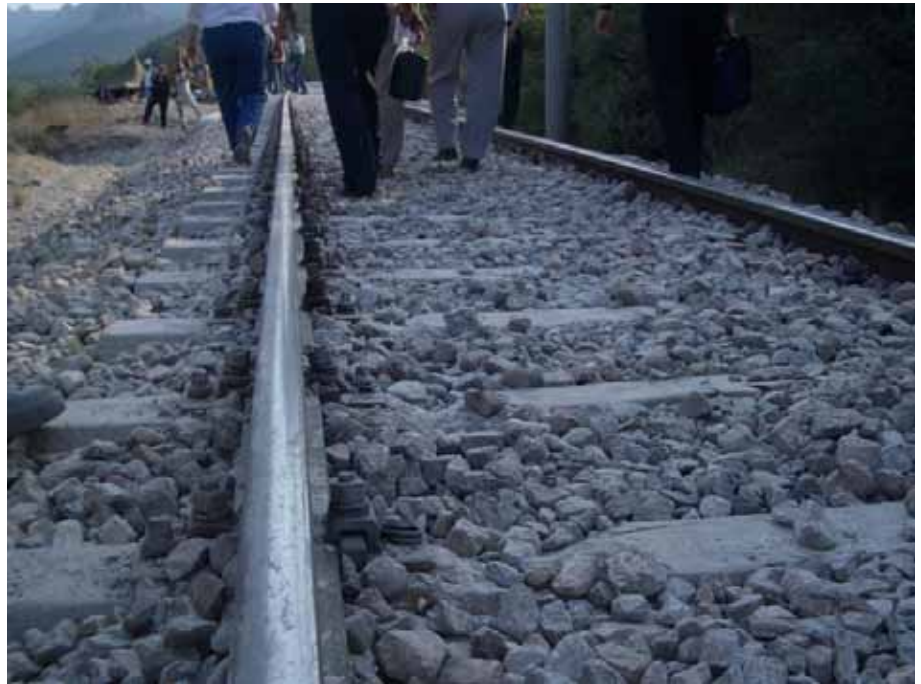
Figure 7 Track damage between point of derailment and Culvert (Ist - Ank)

In Figure 7 damage to the sleepers and fastening system is clearly seen. The right hand wheels were riding on the sleepers close to the left hand rail.

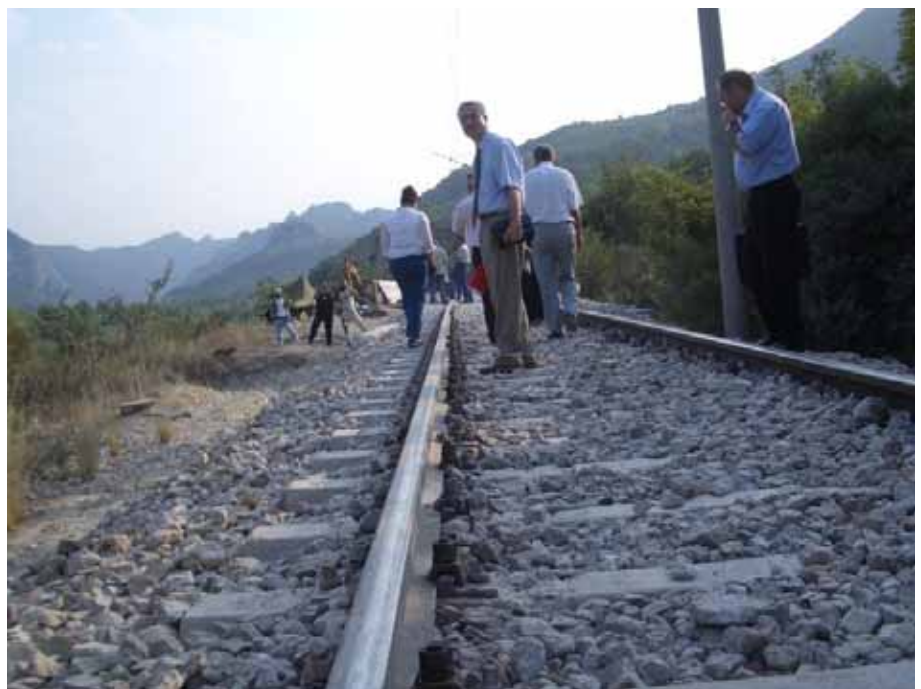
Figure 8 Damage to the track near Culvert (Ist - Ank)

The track just before the culvert. Here the same damage to the track is observed as seen in the previous picture.

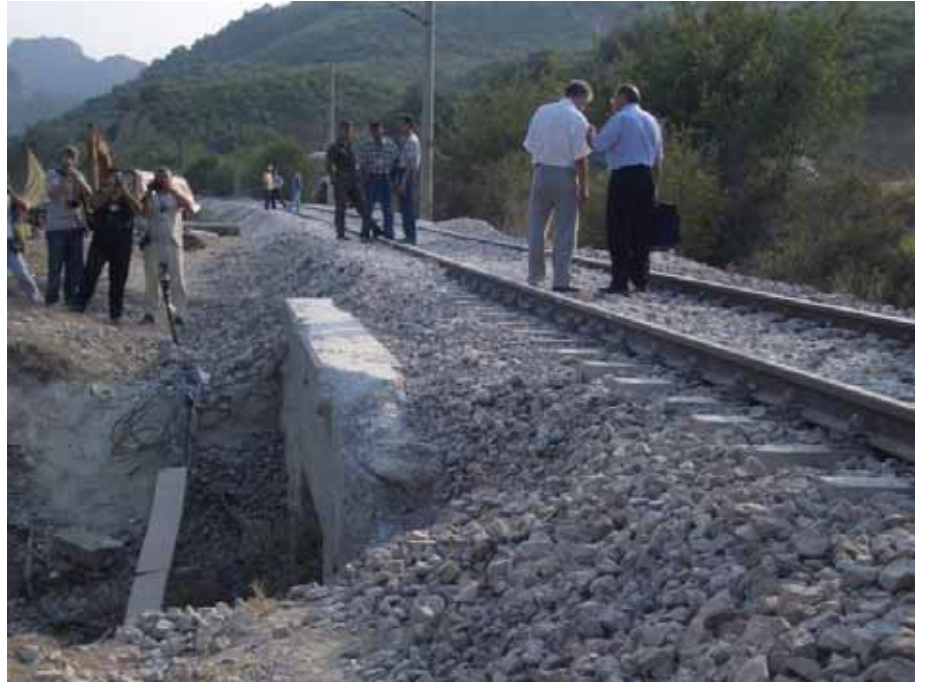
Figure 9 Concrete wall of culvert (Ist - Ank)

The culvert with the concrete wall to which the derailed car (second car behind the loc) collided. From here on the accident escalated. The second coach turned around over 180 degrees and caused the derailment of 3 other cars.

From here on the track was partially destroyed and repaired before my visit to the site took place.

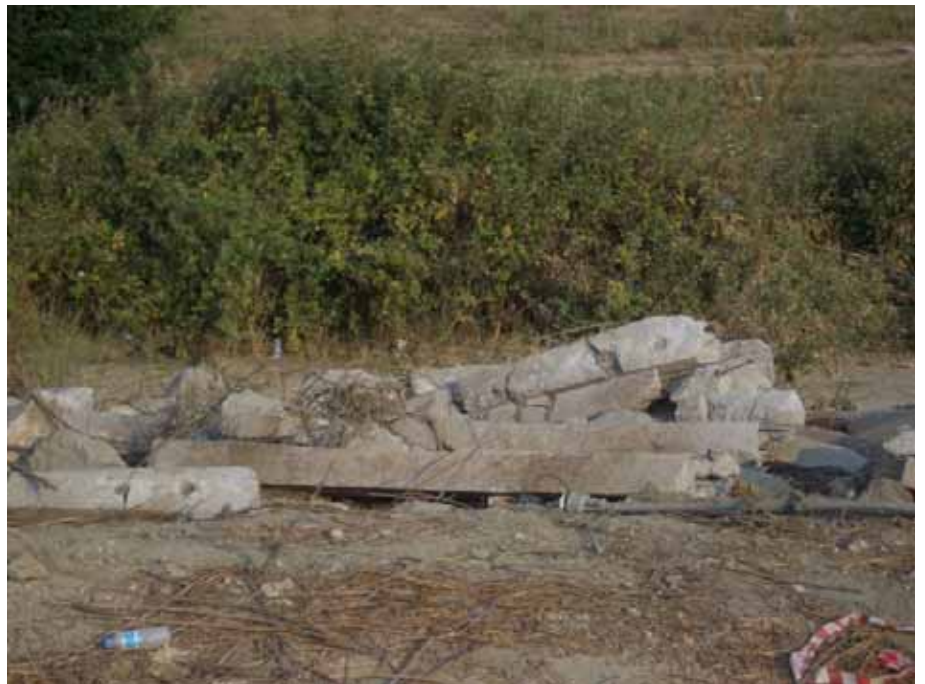
Figure 10 Replaced damaged sleepers left of Ist - Ank

Here some of the replaced damaged sleepers are stored.

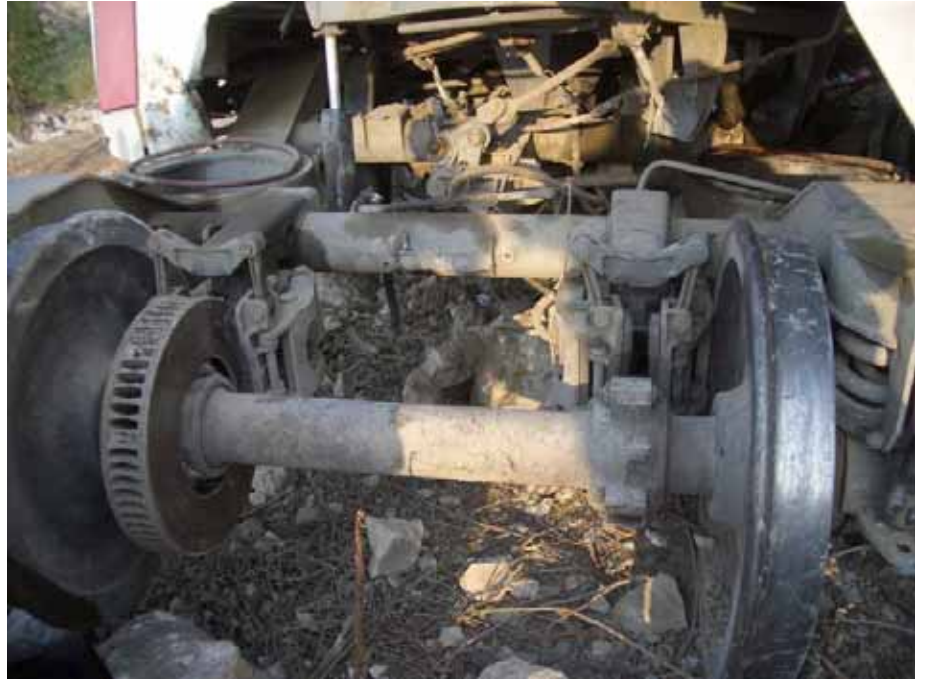
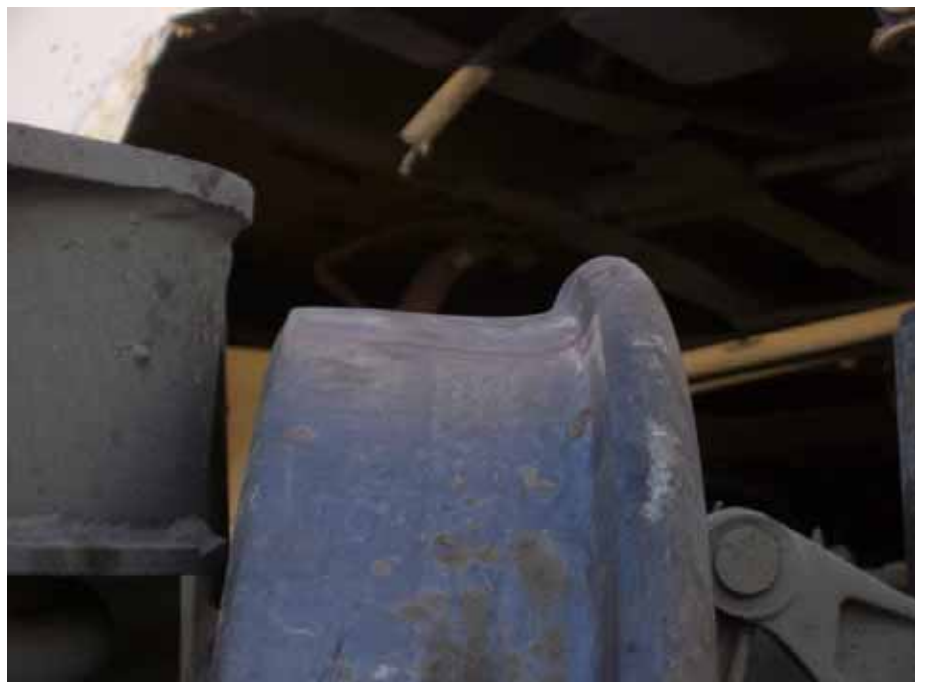
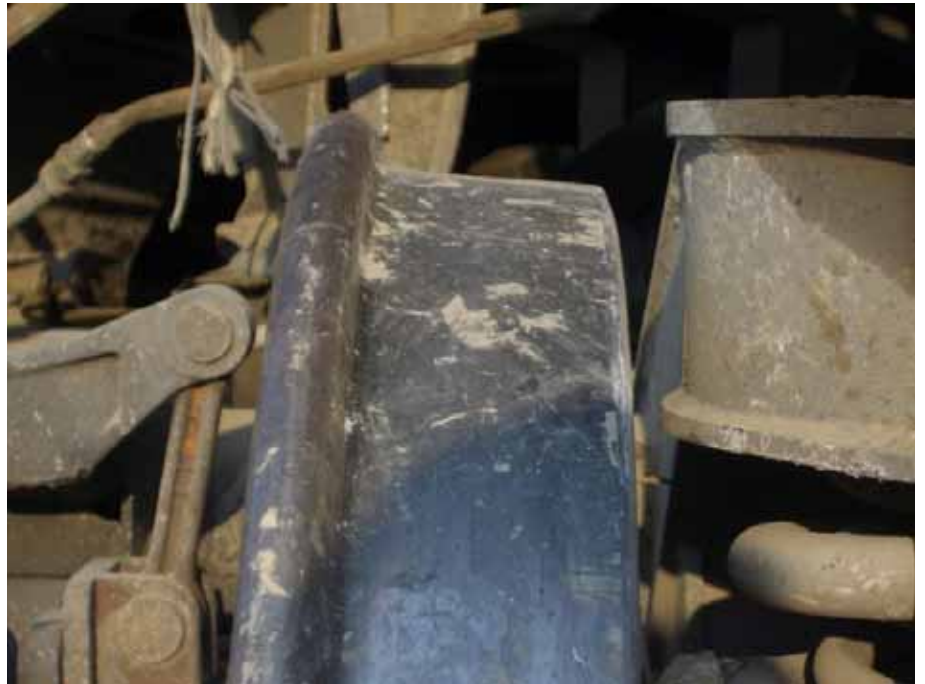
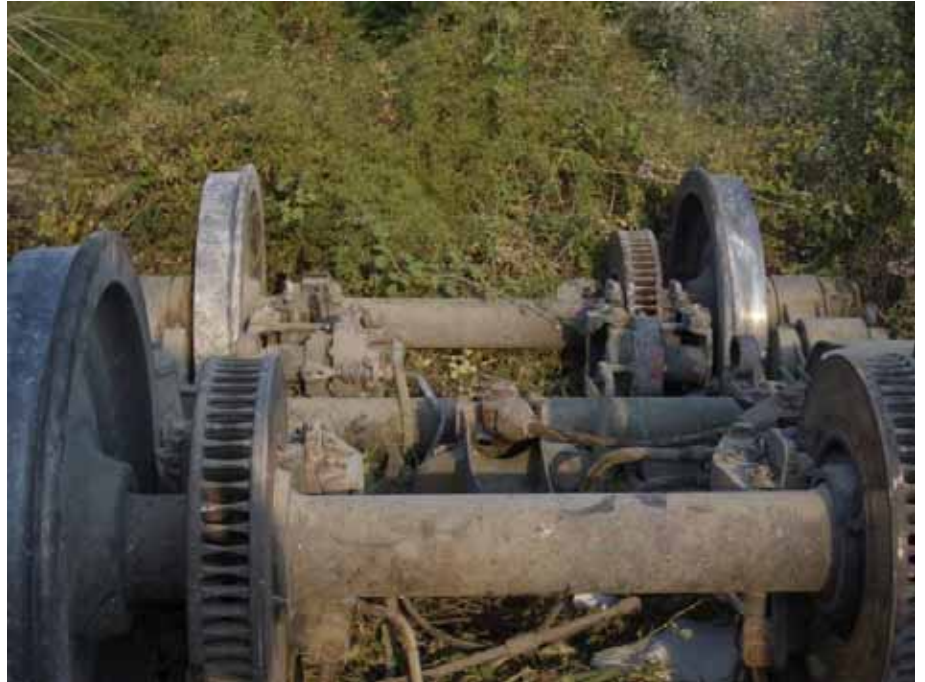
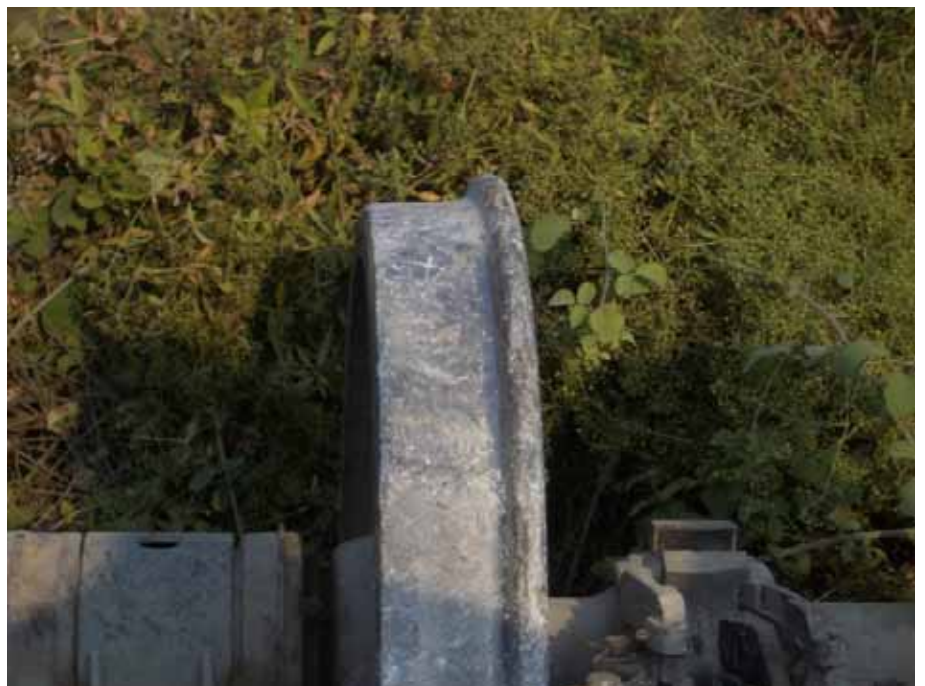
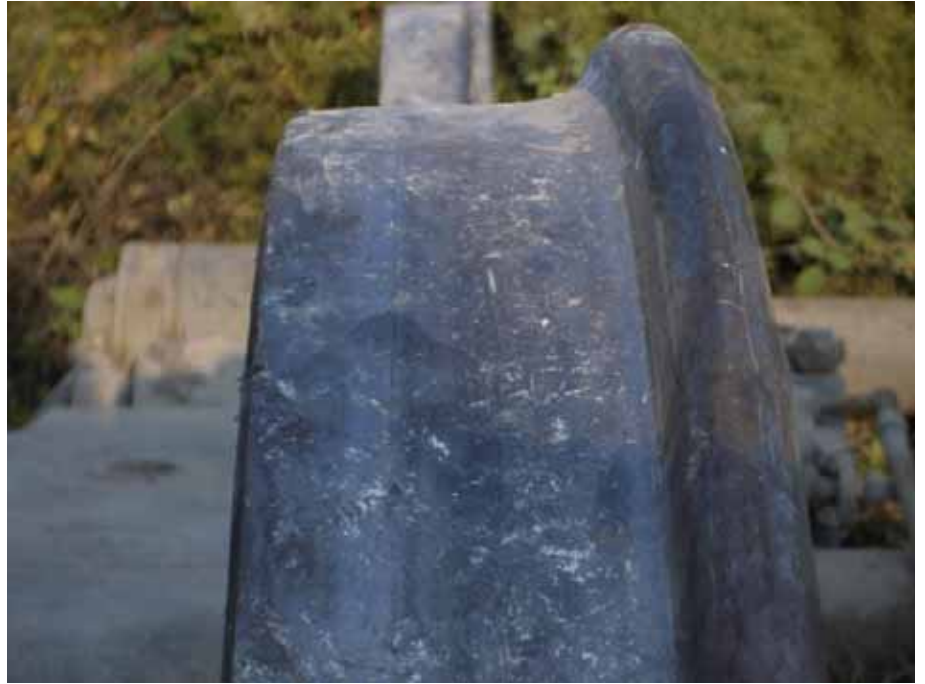
Special attention was given to the wheels because they constitute an important link between vehicle and track. Special attention was given to the occurrence of worn wheels and also hollow wheel threats and false flanges.

In general it could be concluded from the inspection that the wheels were in good condition and no abnormal deviations could be found.
